# Listen Up: Sonos Over-The-Air Remote Kernel Exploitation and Covert Wiretap – BlackHat USA 2024 Whitepaper

Robert Herrera / Alex Plaskett

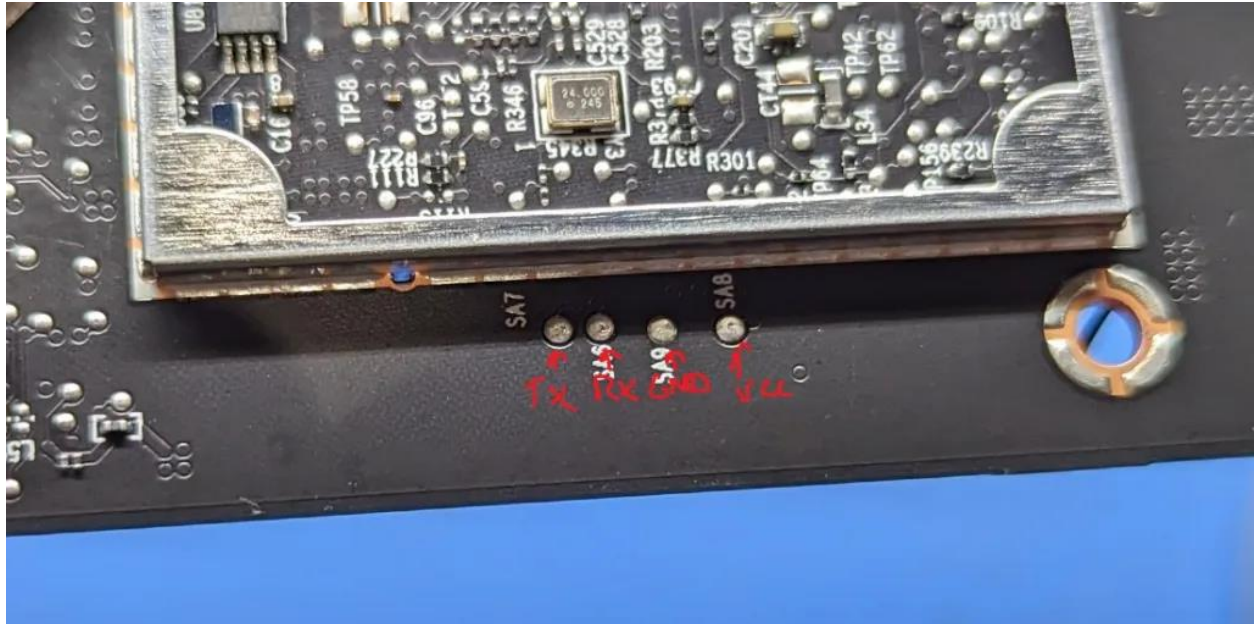
After opening the device, it was possible to quickly identify UART pins broken out on the motherboard:

The pinout is TX, RX, GND, Vcc

This provided the ability to attach a UART adapter and monitor the boot process:

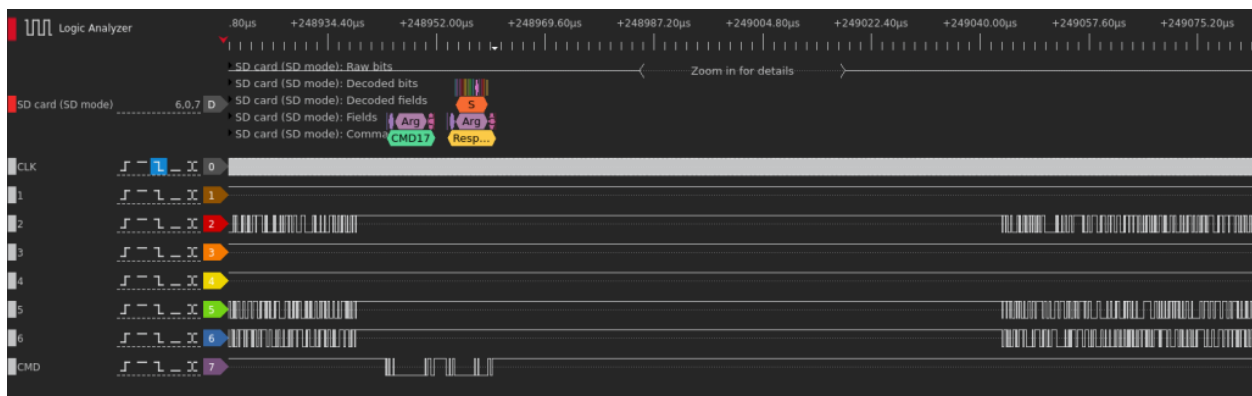
By probing termination resistors and test points located in the general area between the SoC and the eMMC chip, first with an oscilloscope and then with a logic analyzer, it was possible to identify several candidates for eMMC lines.

To perform an in-circuit dump, it is necessary to connect CLK, CMD, DAT0 and ground at the minimum. While CLK and CMD are obvious from the above capture, there are multiple candidates for the DAT0 pin. Moreover, in our research we could only identify 3 out of 4 data pins at this point. Fortunately, after trying all 3 of these, it was possible to identify the following connections:

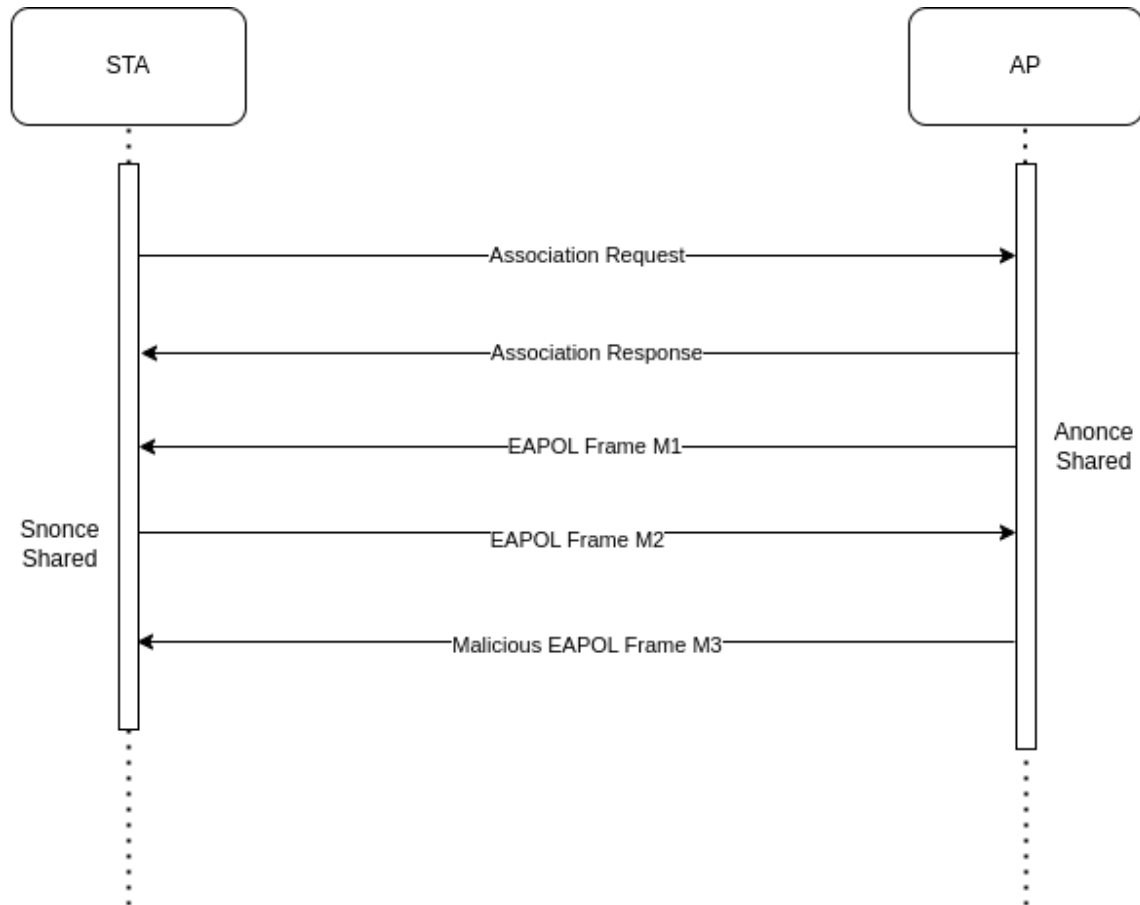
Figure 4: 4-Way Handshake Attack Overview

To trigger the bug, the WPA2 handshake was negotiated normally up until Message 3. Message 3 contained the encrypted keydata that then contained the malicious information element. The attack was follows:

wpa\_supplicant was the perfect tool to quickly test this theory out as we quickly modified EAPOL Message 3 to include the malicious information element and enabled wpa\_supplicant in “AP” mode. From here, we spoofed the SSID and PSK that that the Sonos One had already provisioned to associate to.
